PHOTOGRAPHIC INTELLIGENCE MEMORANDUM

REPORTED FORT AND ARSENAL AT TALANG, CHINA

8 October 1956

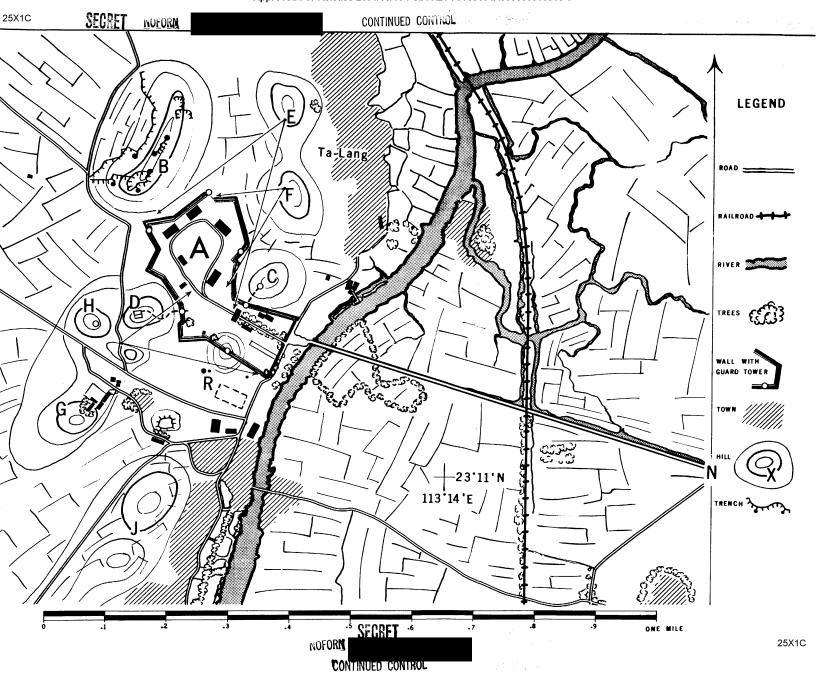
The installation to be observed has been reported as an arsenal. It appears to be a military storage area. The installation occupies an irregular shaped area approximately 1500° x 700° immediately west of a small tributary of the Chu Chiang River. It is located one-half mile west of the Canton-Hankow Railroad and approximately six miles north of Canton. The installation is served by an all-weather two lens highway which connects with the main Canton-Huahsien highway five and one-half miles to the East. Hilitary barracks are found one and one-fourth miles to the northeast and white Cloud Airfield 3.2 miles to the southeast. The town of Talang is one-fourth mile to the northeast and another town is located the same distance to the southwest.

The area labled "A" on the enclosed map is completely surrounded by a wall

except for a 35 foot break at the extreme northern end. This break is adjacent to one of the six guard towers around the wall. A gate or fence probably fills this break in the wall. At the opposite end of the enclosure, entrance is provided by a road leading from the adjoining highway. This entrance is 250 feet west of

a dual lane highest bridge. Four buildings, 135' x 55', with monitor type roofs, are positioned around a loop in the road. What appear to be concrete ramps, extend for a few feet beyond these buildings. A building, 115' x h5', has been built across the road, h50 feet from the highway entrance. All material entering or leaving the four buildings mentioned above would pass through here. Eight smaller buildings of various sizes are dispersed throughout the area. No power facilities or electric transmission lines are visible in the area. At "M" there appears to have been a small industrial site at one time. Nothing remains except one tall amokestack and two shorter ones.

The areas labled "B", "C", "D", and "H" would offer the best vantage points for viewing facilities within the walled area. However, activity, both military and in conjunction with the installation, might make these inaccessible. "B" is a low ridge approximately 1400 ft. long. Abandoned tranches and old weapon emplacements indicates this area has probably been used for military training at one time. "C" is a low hill which would provide an excellent view of all facilities, but an observation post is found at the crest with a faint trail leading to one of the towers at the wall. "B" and "B" are also small hills. A well used trail from one of the guard towers leads to a small structure at "B". A pit or small building foundation is also found here.
